**MUJARRAH CANAL BRIDGE
RAMADI, IRAQ**

**SIGIR PA-09-170
JULY 14, 2009**

Mujarrah Canal Bridge

Summary of Report: PA-09-170

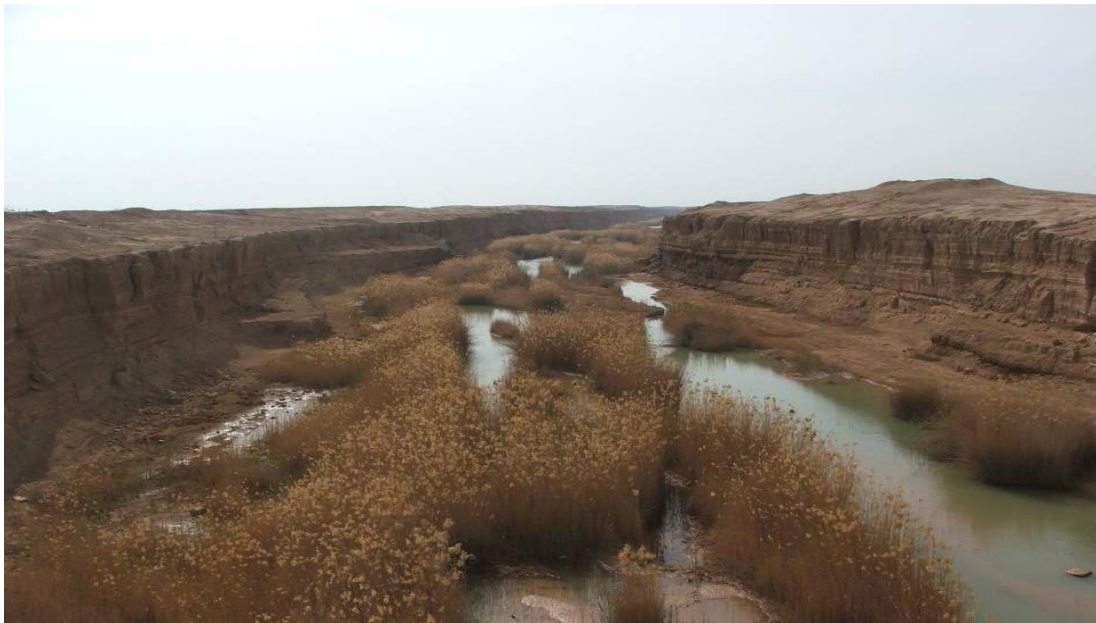
The general topography surrounding the site is level, with no significant changes in elevation. The Mugarrah Canal is the only significant topographic feature in the vicinity, connecting Lake Habbaniyah immediately to the north with Lake Razzazah, approximately 12 kilometers to the south. The canal near the structure is approximately 12 meters (m) deep, with near-vertical sides. The underlying geology appears to be highly erodible, resulting in the deep, approximately rectangular, channel geometry (Site Photo 1).

Site Photo 1. Looking downstream from the Mugarrah Canal Bridge

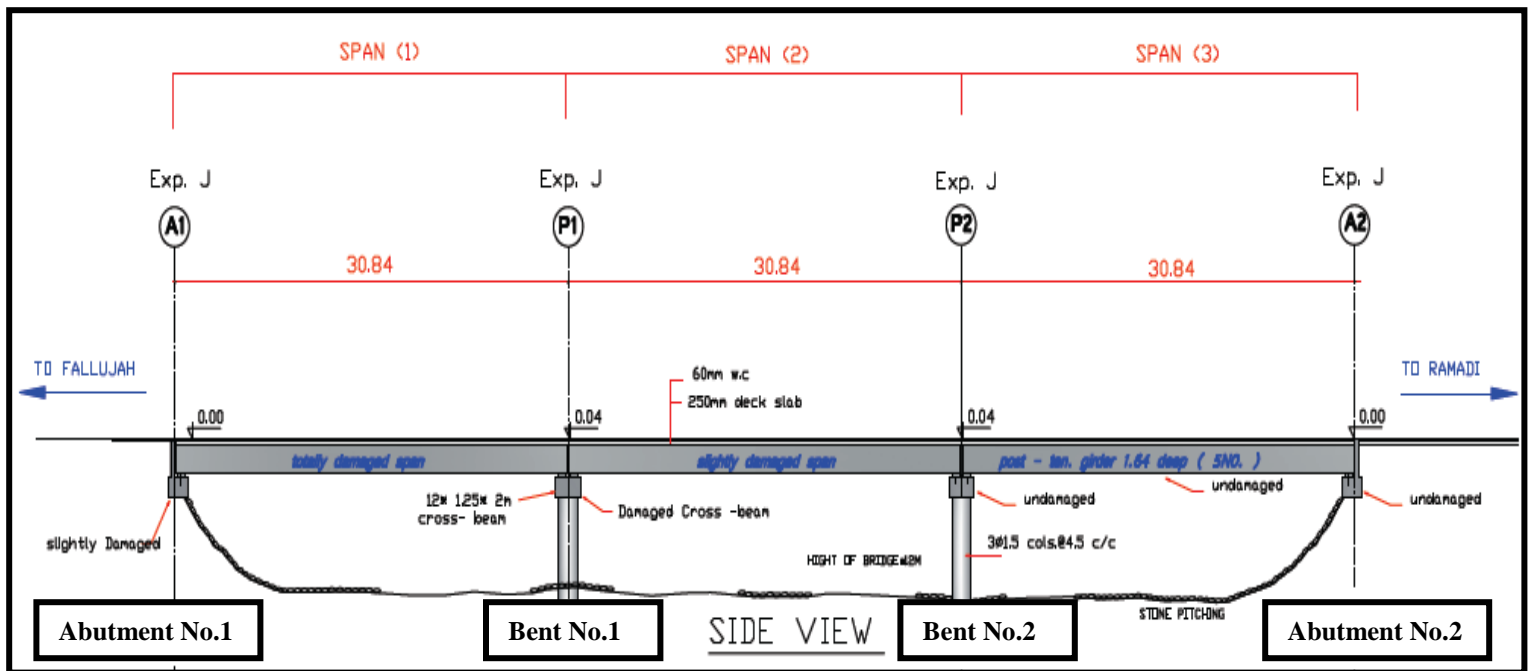
Figure 2. Bridge elevation view (Courtesy of GRC)

The GRC Falluja Resident Office provided SIGIR with the contractor's generated design package. The contractor's site survey identified all degrees of damage to the existing bridge (Figure 2).

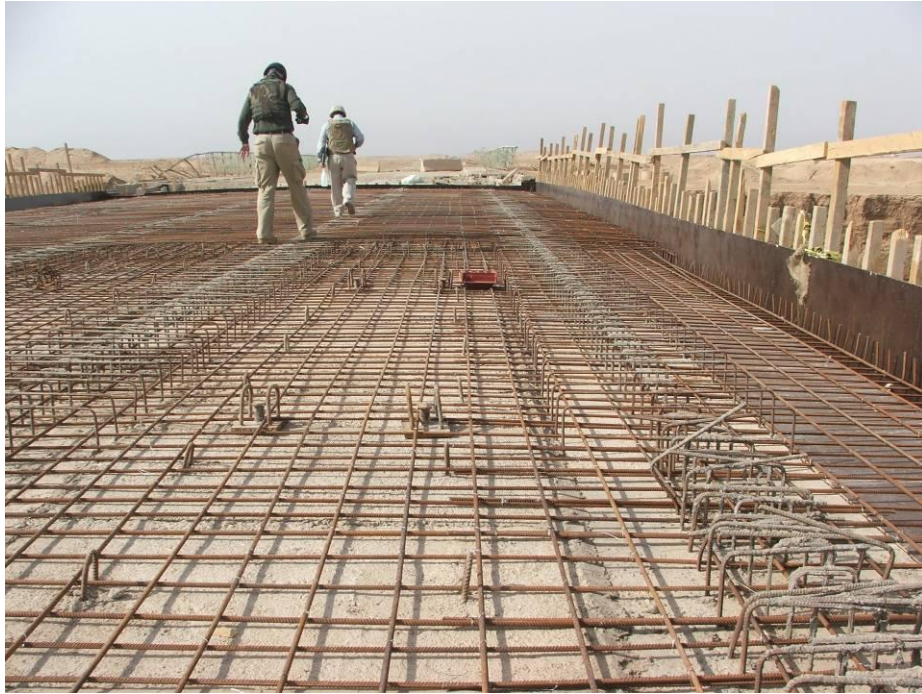
Site Photo 7. Concrete deck reinforcing (prior to placing top mat, foreground)

SIGIR also noted that the bottom mat of reinforcing steel was placed directly on the precast-concrete deck pans. To provide composite action between the reinforcing and the concrete deck, adequate cover needs to be obtained around the reinforcing to permit stress transfer. Inadequate cover may result in the reduced capacity of the deck. SIGIR understands that it is a common practice for contractors to place chairs under reinforcing steel immediately before concrete placement. This helps avoid bending the chairs or rebar when walking on the matting as shown in Site Photo 7. If the contractor placed adequate chairs under the reinforcing steel prior to concrete placement, this is not an issue.

In addition, any moisture penetrating the concrete deck will most likely gather between the poured concrete deck and the precast-concrete deck pans. Without adequate concrete cover, the reinforcing steel will be vulnerable to corrosion and deterioration, which would result in decreased load-carrying capacity and/or accelerated deterioration of the deck.

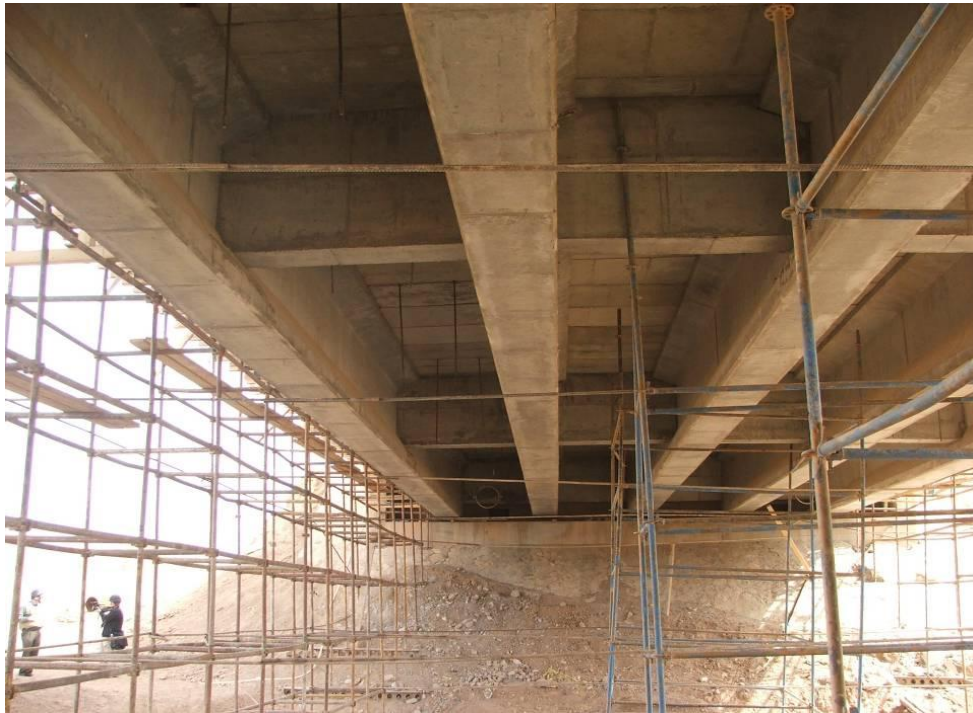
The post-tensioned concrete girders appeared to be constructed per the contractor’s design drawings. SIGIR observed placement and uniform spacing aligned with the existing construction (Site Photo 10). Due to time constraints, SIGIR could not verify the sweep and chambers of the beams; however, GRC Falluja Resident Office representatives stated that the beams were within the tolerance of the design at the time of placement.

Site Photo 10. Post-tensioned concrete girders

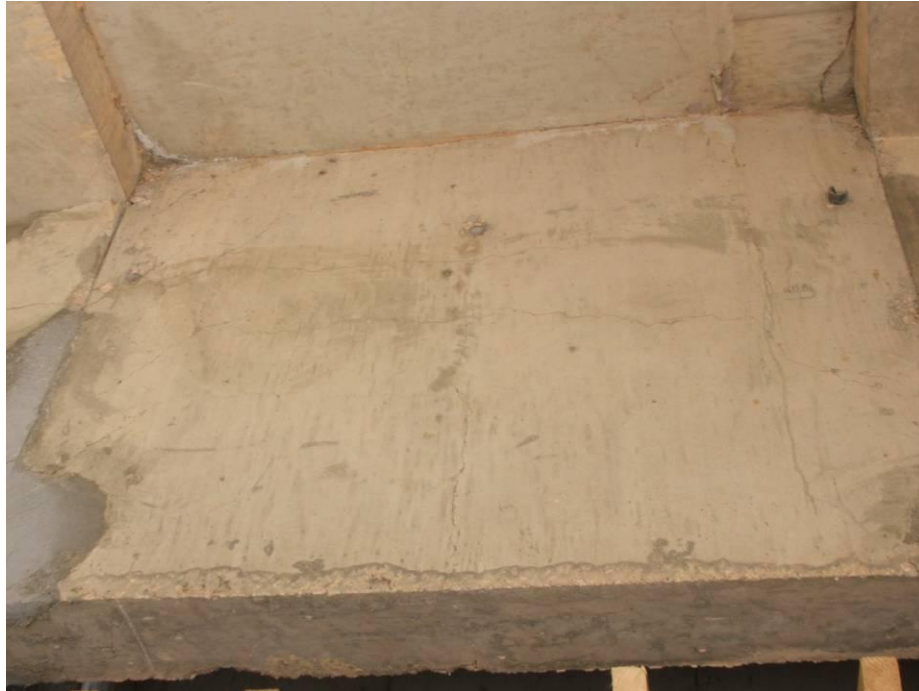
SIGIR examined some of the existing bridge structure near Pier Cap No. 1. Several of the end diaphragms for Span No. 2 had been damaged in the VBIED detonation, and the panels show varying degrees of attempted repair.

The existing end-diaphragm panel near the center of the pier appeared to have been shattered (Site Photo 14). The horizontal and vertical cracking through the center of the panel indicated that the panel has completely failed and offered limited resistance as a diaphragm. An attempt appeared to have been made to patch some of the damaged areas of the panel; however, due to its complete failure, a more comprehensive repair or complete replacement of this panel should have been considered.

Site Photo 14. Existing damaged diaphragm at Bent No. 1
